ENGINE

Engine And Gearbox Suspension - Repair Instructions - F25

22 11 011 REPLACING LEFT ENGINE MOUNT (N20)

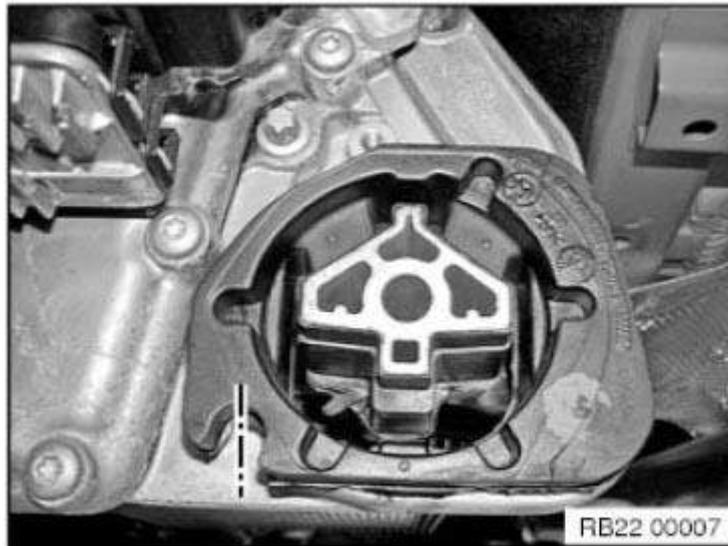
Fig. 28: Identifying Rubber Mount Installation Position
Courtesy of BMW OF NORTH AMERICA, INC.

Arrow on rubber mount must point to arrow on housing.

Coat housing bore and rubber mount with Circolight.

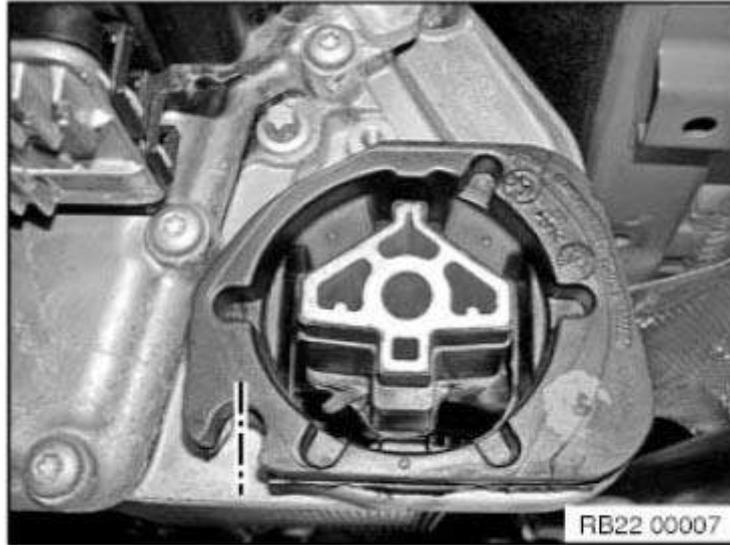
Fig. 32: Identifying Rubber Mount Installation Position

Arrow on rubber mount must point to arrow on housing.

Coat housing bore and rubber mount with Circolight.

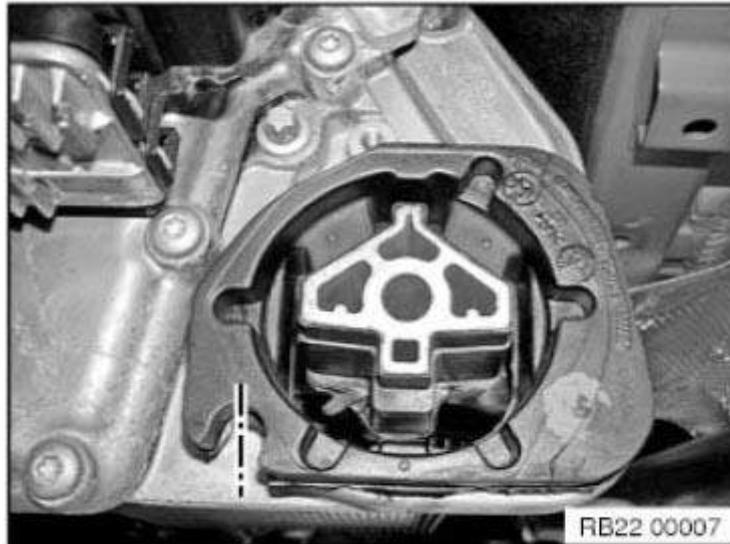
Fig. 36: Identifying Rubber Mount Installation Position

Arrow on rubber mount must point to arrow on housing.

Coat housing bore and rubber mount with Circolight.

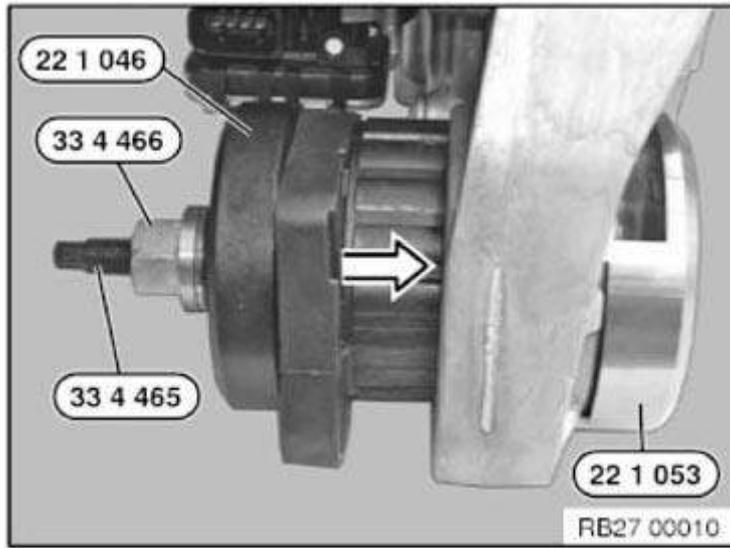
Fig. 38: Installing Rubber Mount Using Special Tools (22 1 046)
Courtesy of BMW OF NORTH AMERICA, INC.

Draw in rubber mount with special tools [22 1 046](#) / [22 1 053](#) / [33 4 465](#) and [33 4 466](#) .

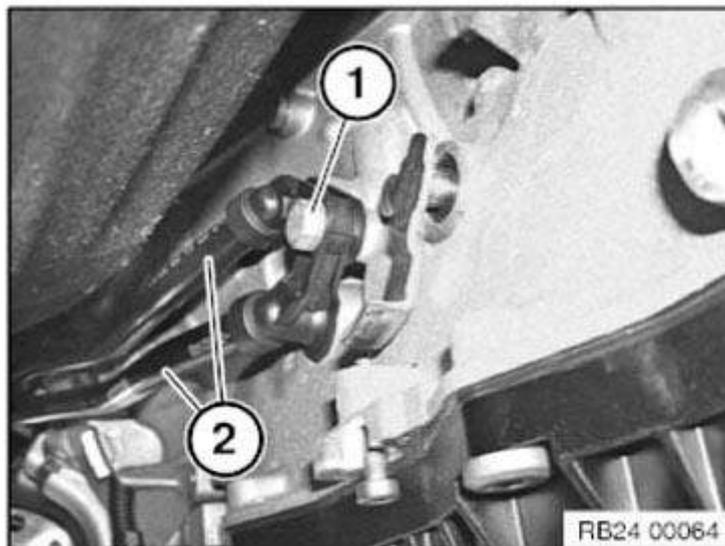
Fig. 8: Identifying Hydraulic Lines To Transmission Oil Cooler And Screw

Replace sealing rings.

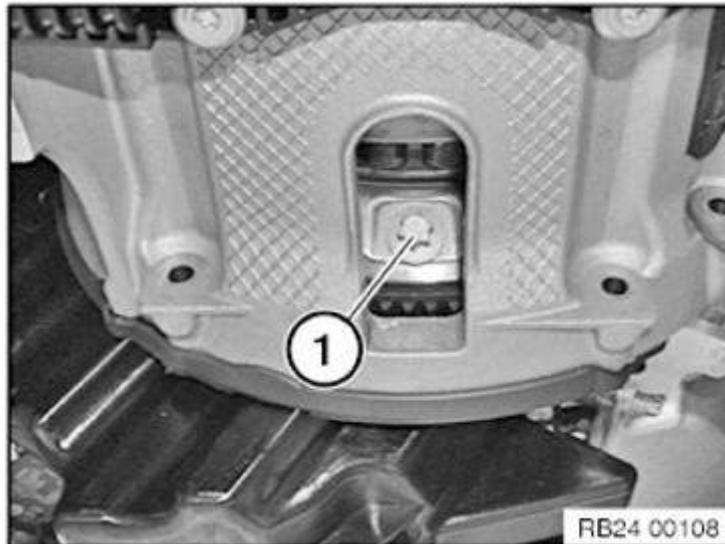
Fig. 11: Identifying Vibration Damper Screw

IMPORTANT: Replace all 6 bolts on torque converter.

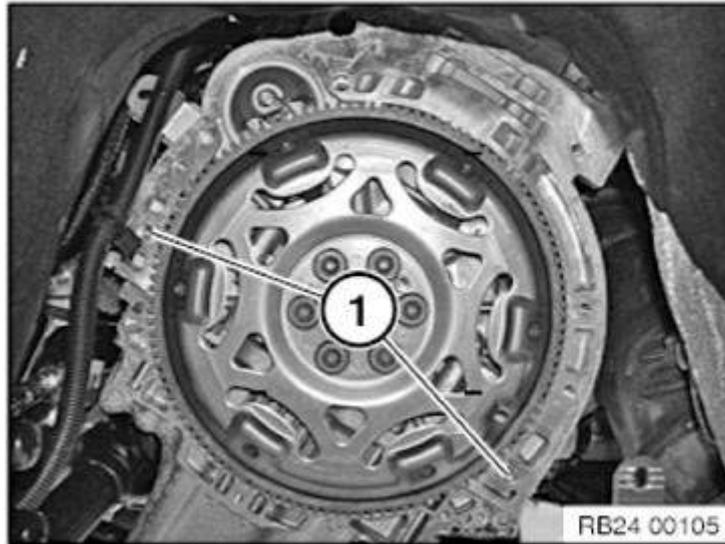
Fig. 18: Identifying Fitting Sleeves

Replace damaged fitting sleeves.

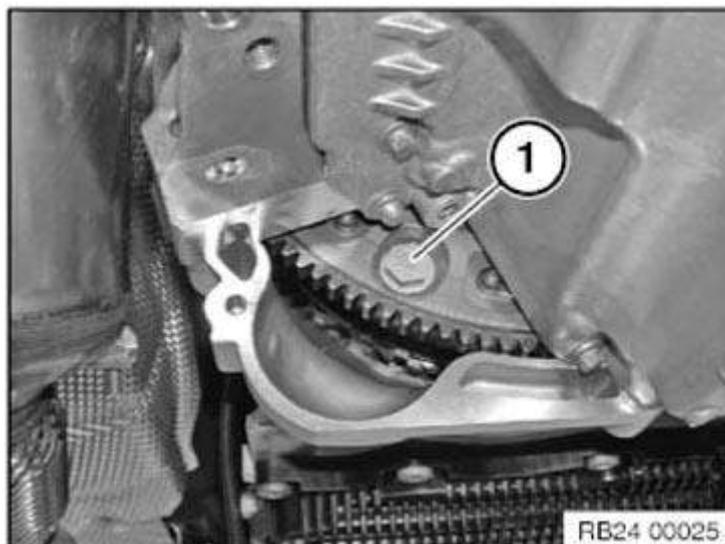
Fig. 27: Identifying Vibration Damper Screws
 Courtesy of BMW OF NORTH AMERICA, INC.

Replace converter screws. Remove any remaining adhesive residue from the thread.

Tightening torque [24 40 1AZ](#) .

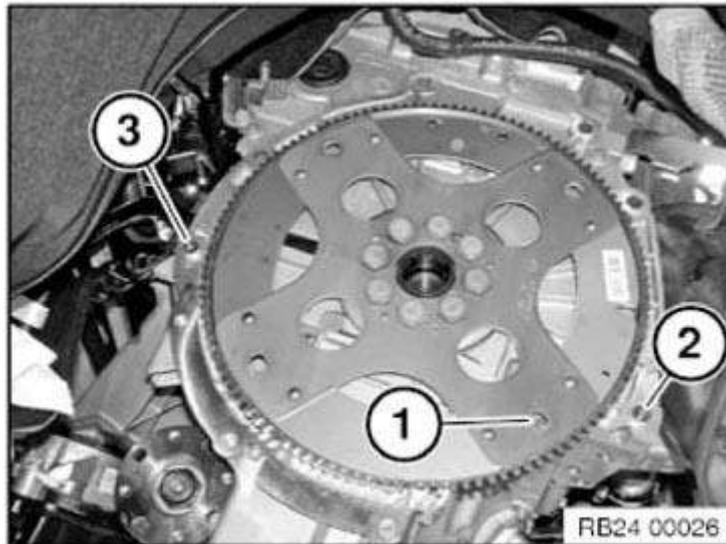
Fig. 29: Identifying Driving Plate Bore Hole And Fitting Sleeves
Courtesy of BMW OF NORTH AMERICA, INC.

Replace damaged fitting sleeves.

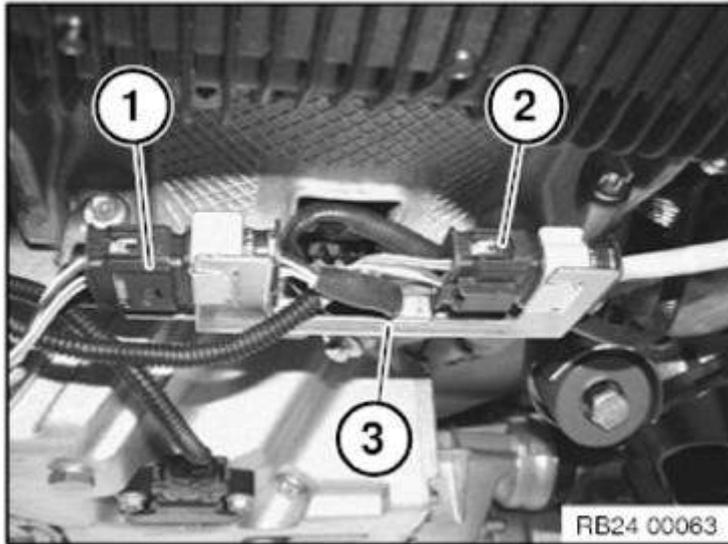
Fig. 30: Identifying Connectors From Bracket
Courtesy of BMW OF NORTH AMERICA, INC.

Disconnect connectors (1) and (2) from bracket (3) and detach.

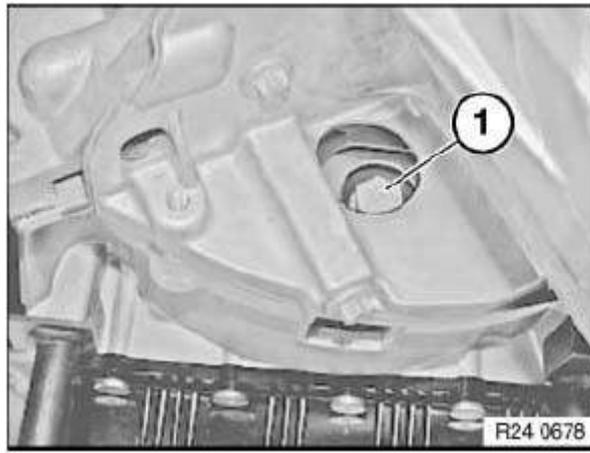
Fig. 42: Identifying Vibration Damper Screw
Courtesy of BMW OF NORTH AMERICA, INC.

Replace converter screws. Remove any remaining adhesive residue from the thread.

Tightening torque [24 40 1AZ](#) .

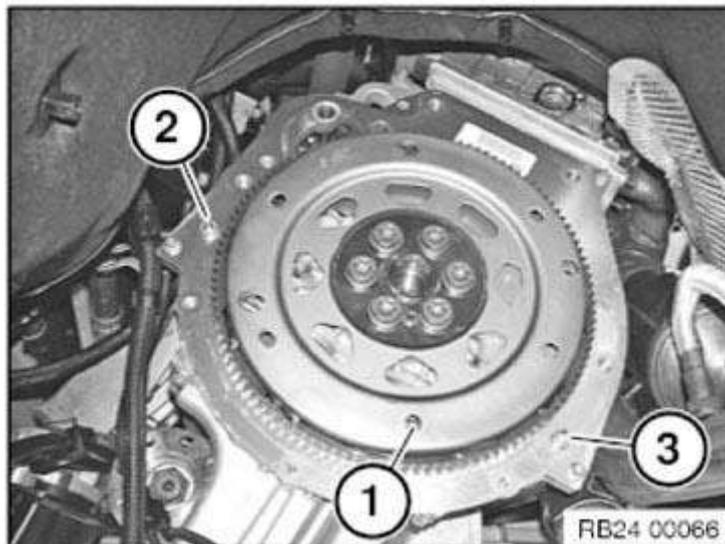
Fig. 45: Identifying Fitting Sleeves And Driving Plate Bore Hole

Replace damaged fitting sleeves.

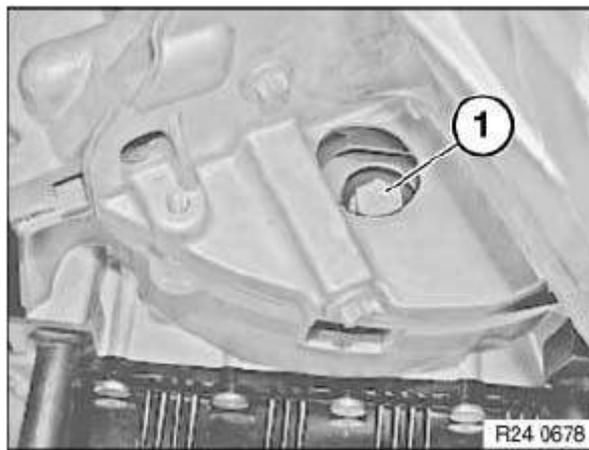
Fig. 57: Identifying Vibration Damper Screw
 Courtesy of BMW OF NORTH AMERICA, INC.

Replace converter screws. Remove any remaining adhesive residue from the thread.

Tightening torque [24 40 1AZ](#) .

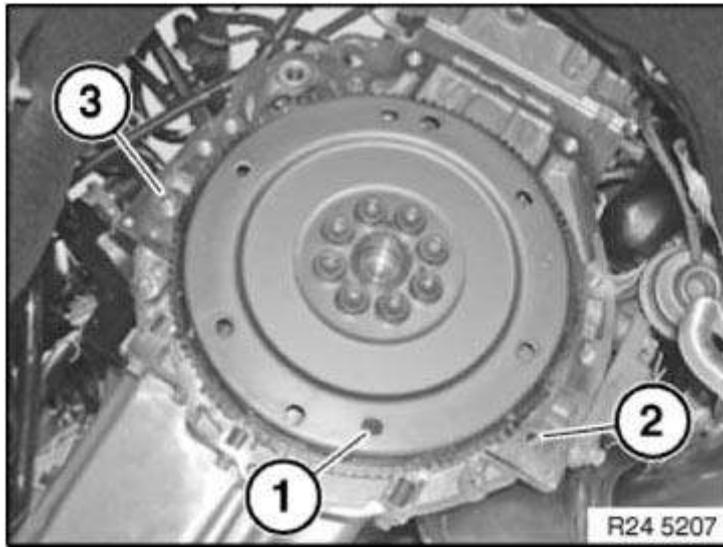
Fig. 60: Identifying Driving Plate Bore Hole And Sleeves

Replace damaged fitting sleeves.

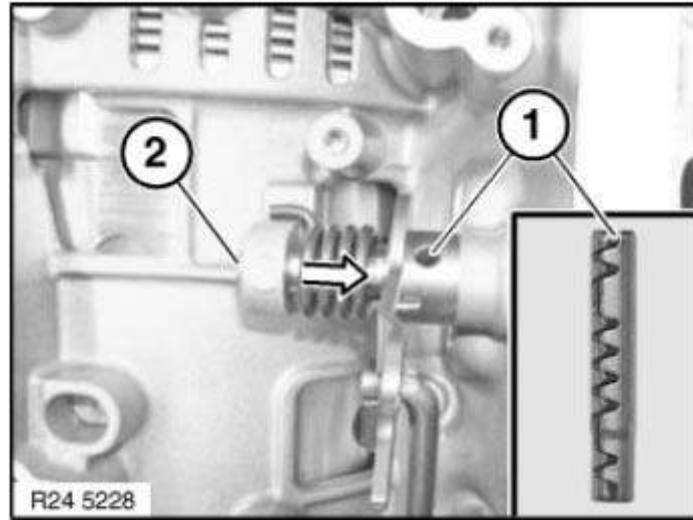
Fig. 69: Driving Clamping Sleeve Out Of Selector Shaft

Replace selector shaft (2).

Replace clamping sleeve (1).

Insert narrower end of clamping sleeve (1) into hole first. Using a suitable tool, drive in clamping sleeve until it is flush with the hole.

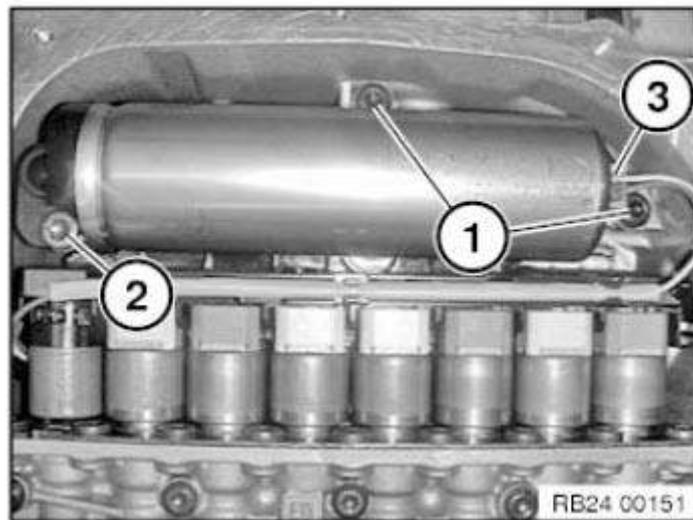
Fig. 73: Identifying Oil Accumulator, Connector And Screw
Courtesy of BMW OF NORTH AMERICA, INC.

IMPORTANT: Mounting bolts of oil accumulator must be replaced after removal.

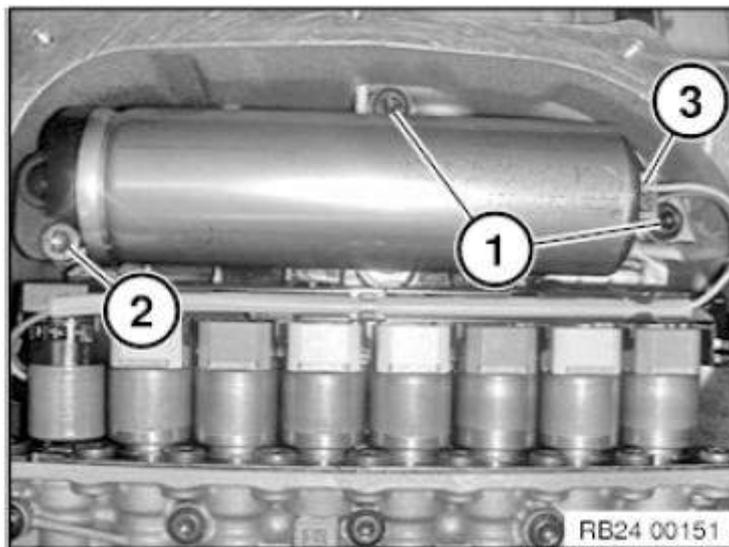
Fig. 74: Identifying Oil Accumulator, Connector And Screw

IMPORTANT: Mounting bolts of oil accumulator **must** be replaced after removal.

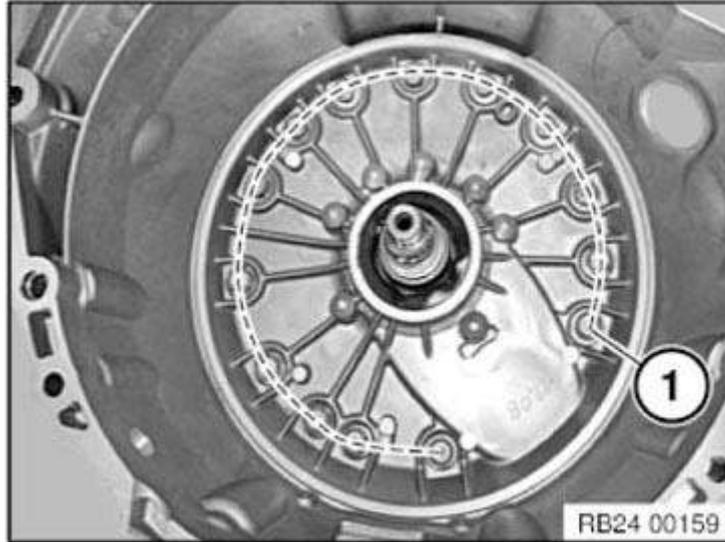
Fig. 77: Identifying Drive Shaft Screw

When replacing screws (1) along the dashed line, always change one screw after the other.

Tightening torque [24 30 6AZ](#).

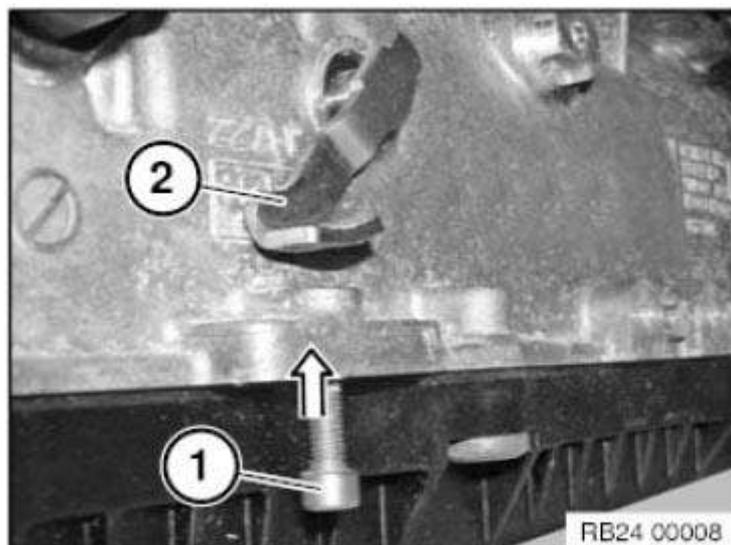
Fig. 79: Removing Underbody Protection Screw
Courtesy of BMW OF NORTH AMERICA, INC.

- Remove underbody protection
- Screw in screw (1) with hexagon socket (SW5) until parking lock is released by lever (2).
- It is **imperative** that bolt is always replaced.
- Clean thread with screw tap size M6X1, 0.

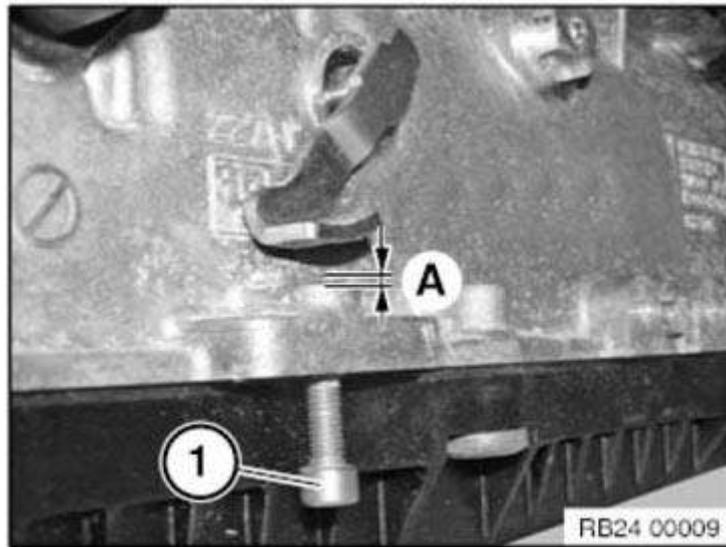
Fig. 80: Identifying Thread Lip Dimension
Courtesy of BMW OF NORTH AMERICA, INC.

Screw new microencapsulated screw (1) into thread.

The screw may no longer be turned after 3 minutes (hardening of adhesive), otherwise it must be replaced.

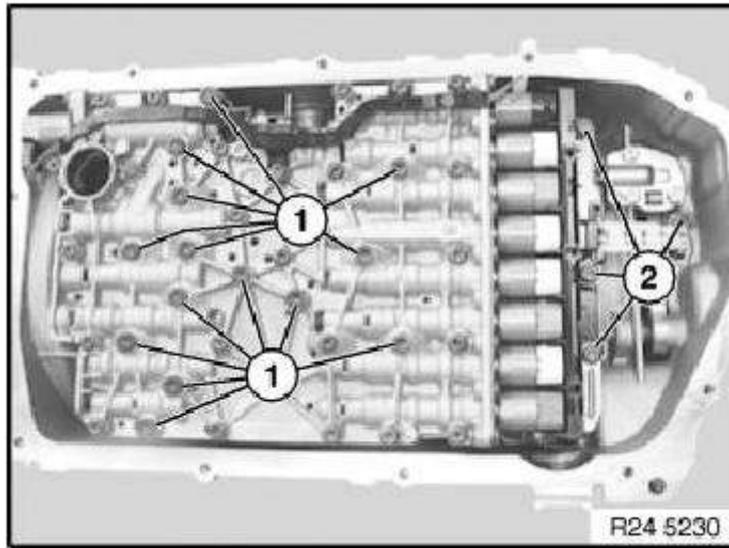
Fig. 90: Identifying Mechatronics Unit Mounting Screws (For Vehicles Without Oil Reservoir)
Courtesy of BMW OF NORTH AMERICA, INC.

Replace O-rings for oil ducts on the mechatronics unit and wet with automatic transmission fluid.

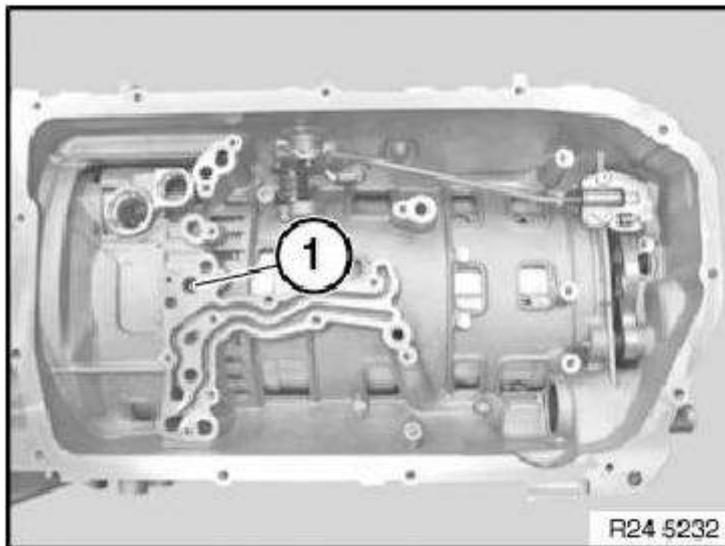
Fig. 92: Identifying Gasket
Courtesy of BMW OF NORTH AMERICA, INC.

Coat new gasket with automatic transmission fluid and install.

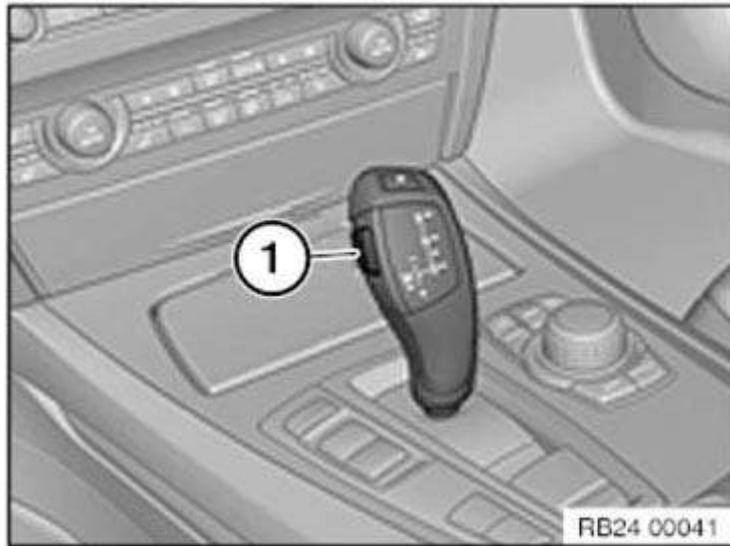
Fig. 101: Identifying Release Button

- Switch the ignition on.
- Apply the brake pedal and hold it down during the entire procedure.
- Press start/stop button.
- The starting operation may last for some seconds in low ambient temperatures and for diesel engines.
- As soon as the starter motor can be heard to operate
- Press and hold down the release button (1)

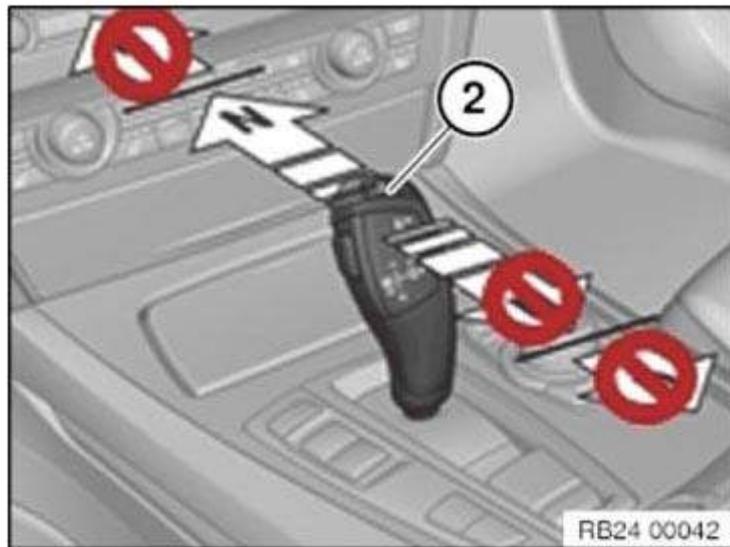
Fig. 102: Pushing Selector Lever

1. The specified time must necessarily be complied with!
2. Push selector lever (2) forward up to point of resistance and hold for 2 seconds.
3. Release the selector lever and quickly move it forward by another level again.

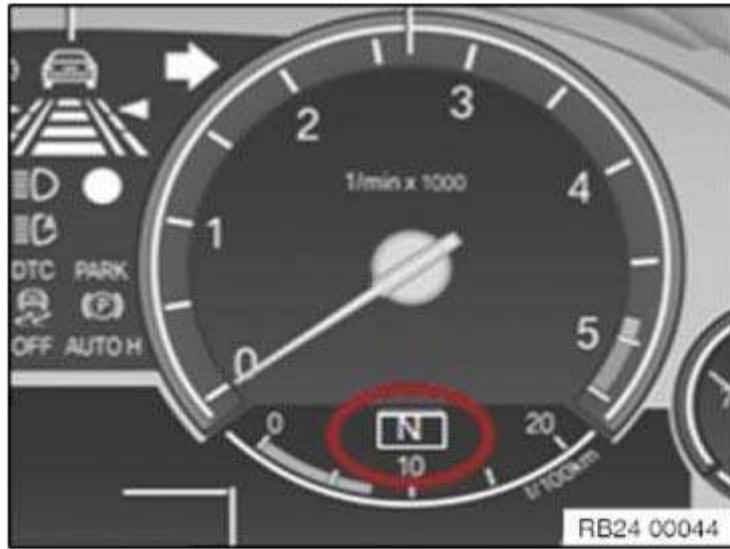
Fig. 103: Identifying Gear Position N On Instrument Panel

- The selector lever position N is displayed in the instrument cluster.
- The transmission lock is now electronically unlocked.
- Release the brake pedal after the transmission lock has been successfully unlocked.
- Leave the ignition switched on in order to subsequently move the vehicle.
- The transmission automatically shifts into P when the ignition is turned off.

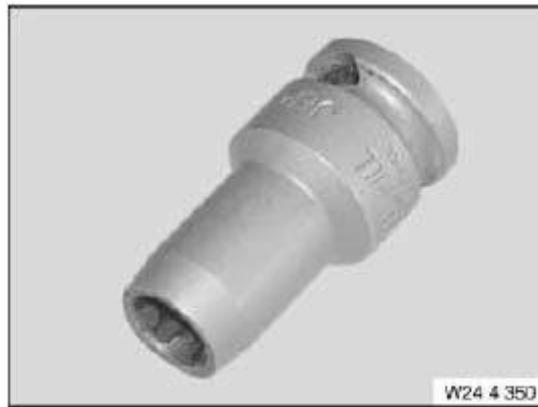
Fig. 182: Identifying Socket WAF 46 (0495598)
Courtesy of BMW OF NORTH AMERICA, INC.

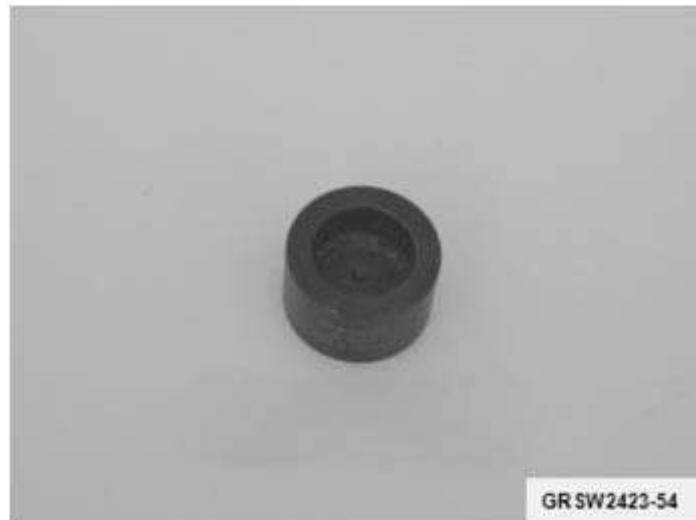
Fig. 198: Identifying Synchronising Key (0495597)
Courtesy of BMW OF NORTH AMERICA, INC.

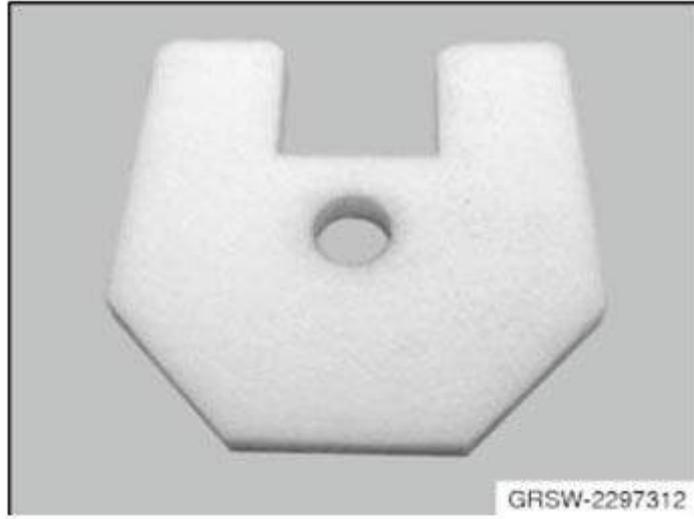
NOTE: For setting down the removed E-machine (risk of damage).

Fig. 217: Identifying Oddments Tray (2297312)

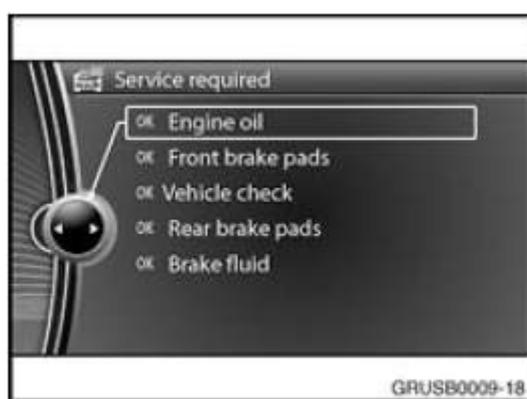
The Service required screen displays all the maintenance items and their current status.

Fig. 5: Central Information Display - Service Required Screen
 Courtesy of BMW OF NORTH AMERICA, INC.

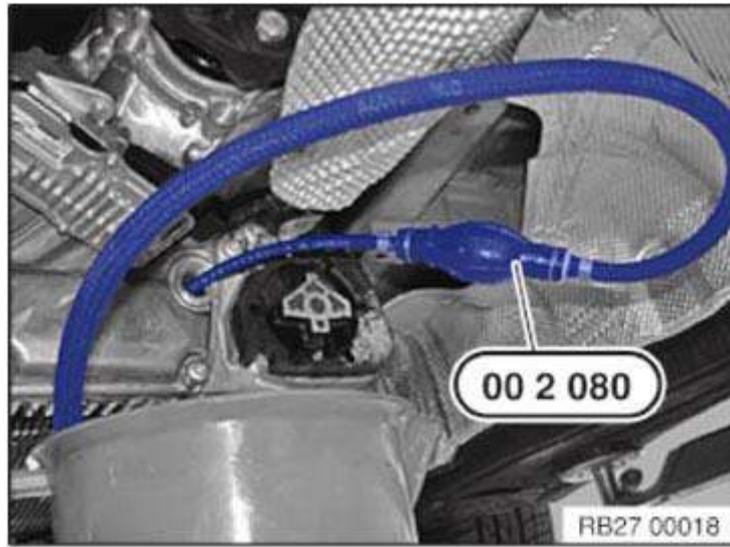
Use special tool [00 2 080](#) to draw off and dispose of transmission oil.

- Drawn off oil volume \geq 500 ml.
- Observe country-specific waste disposal regulations

Fig. 2: Identifying Special Tool (00 2 080)

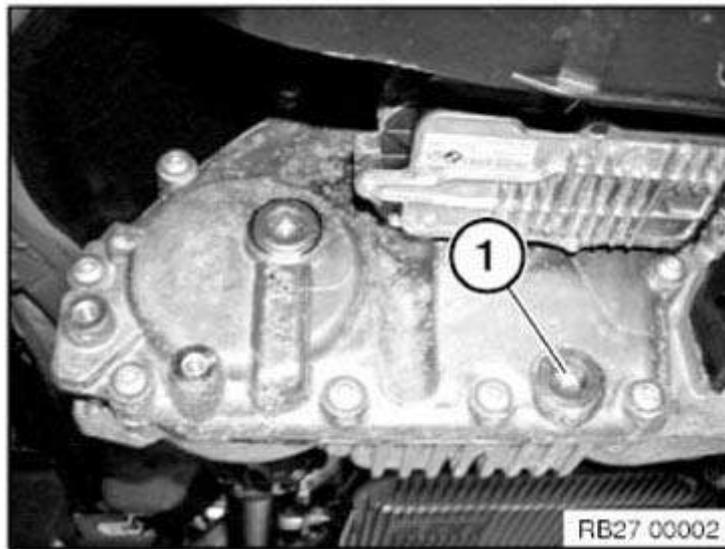
Fig. 5: Identifying Oil Drain Plug

Replace oil drain plug (1).

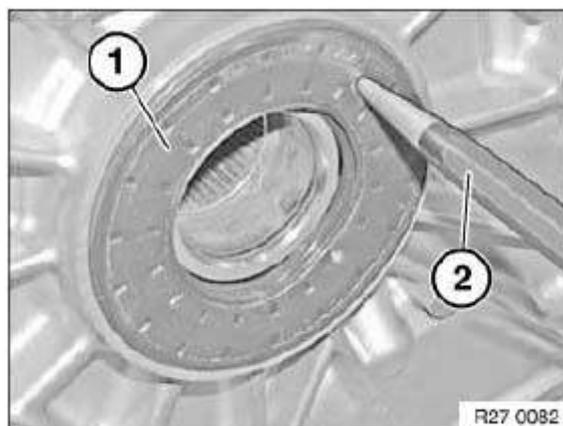
Fig. 47: Drilling Hole Into Radial Shaft Seal

IMPORTANT: Do not use a drill as swarf may result in transmission failure.

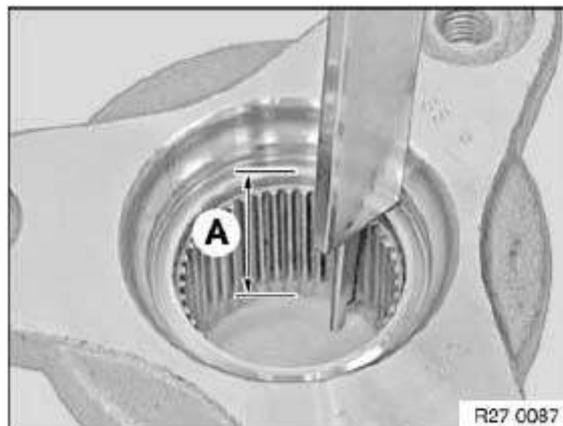
- Thickness of new shim must be determined before output flange is installed

Determine and note down dimension A of output flange (old and new).

Fig. 53: Checking Output Flange Dimension A

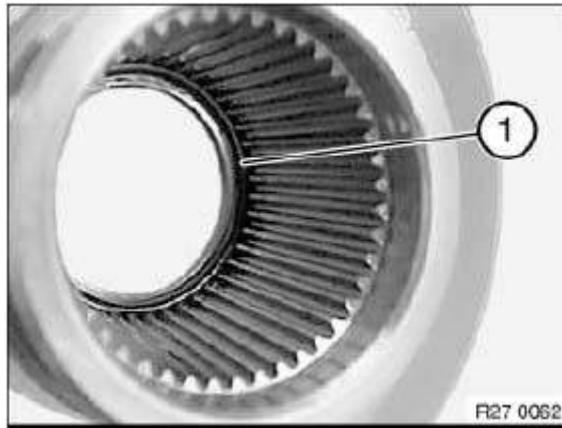
Fig. 71: Identifying O-Ring

Check that O-ring is in correct position.

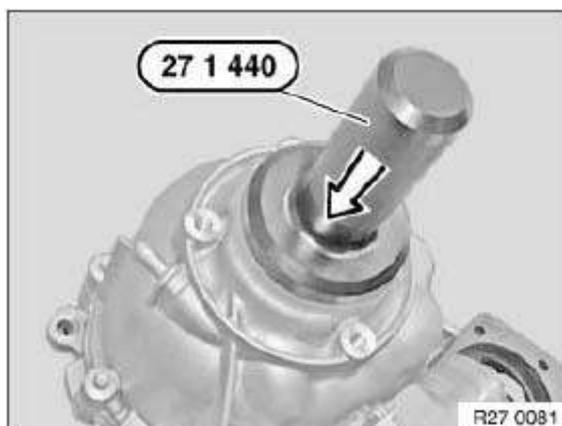
Coat sealing lips of new radial shaft seal with clean transmission oil.

Drive in radial shaft seal with special tool [27 1 440](#) .

Fig. 77: Installing Radial Shaft Seal

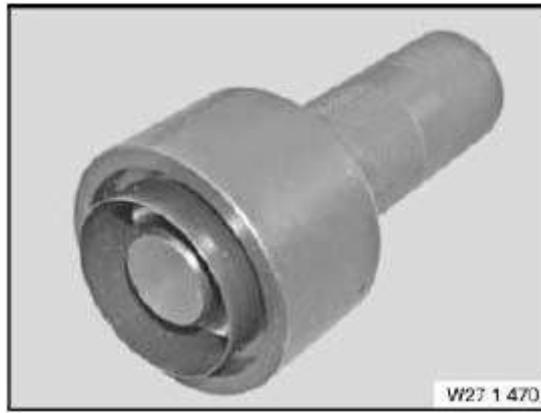
Fig. 19: Identifying Mandrel (0495764)
Courtesy of BMW OF NORTH AMERICA, INC.

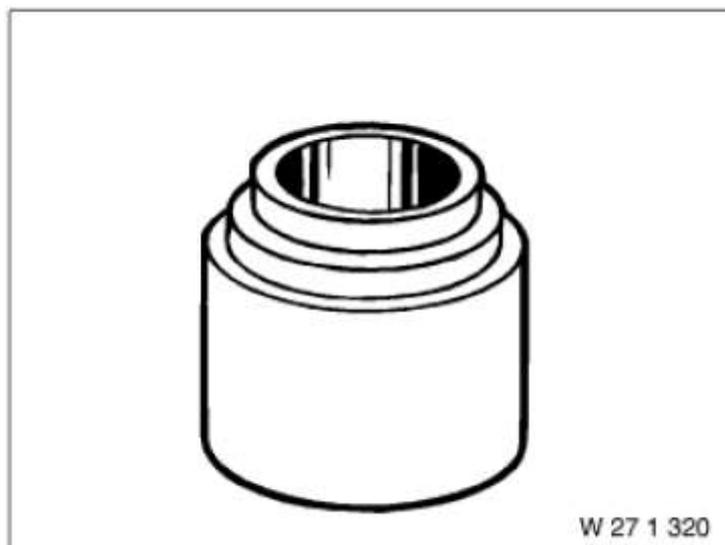
Fig. 22: Identifying Mandrel (0491848)

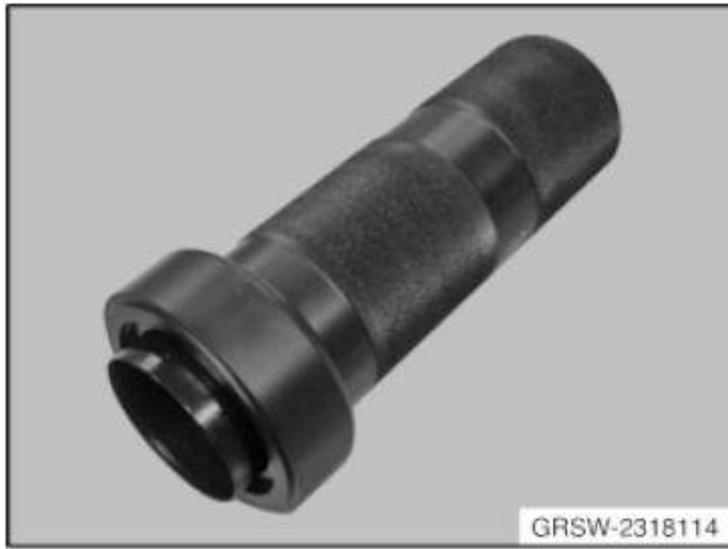
Fig. 29: Identifying Mandrel (2318114)

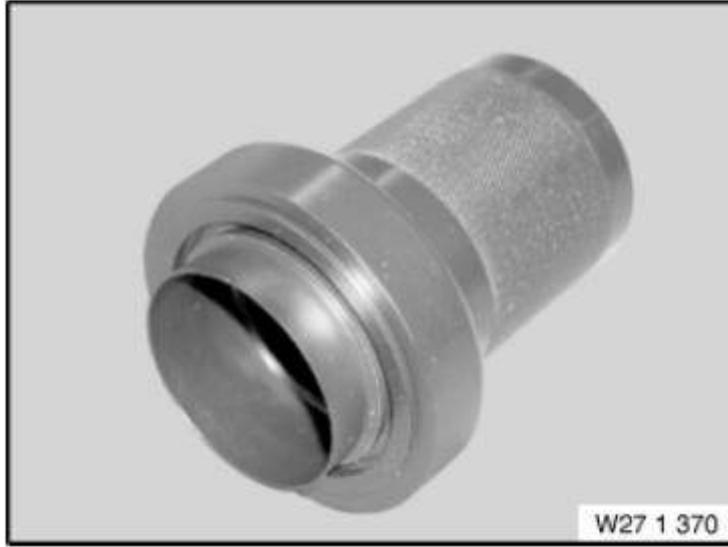
Fig. 31: Identifying Mandrel (0494640)
Courtesy of BMW OF NORTH AMERICA, INC.

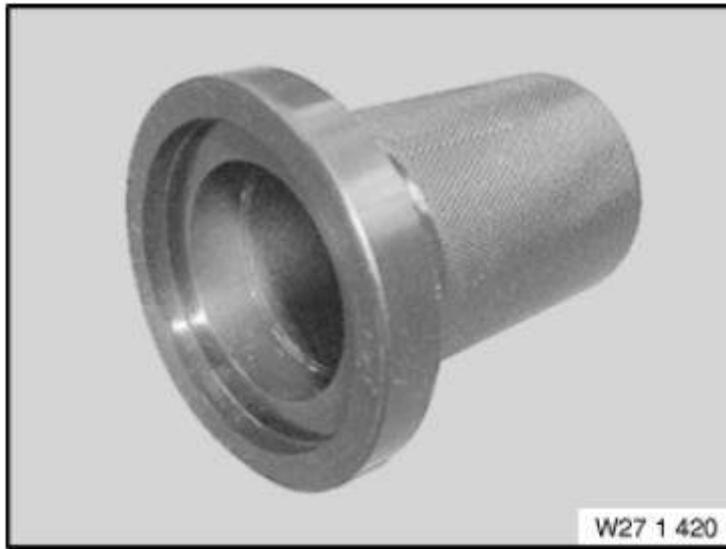
Fig. 35: Identifying Mandrel (0494823)

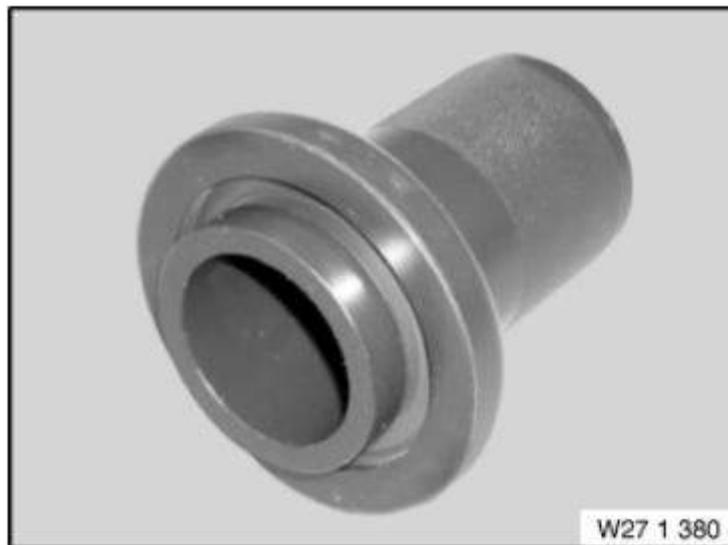
Fig. 38: Identifying Mandrel (0494641)

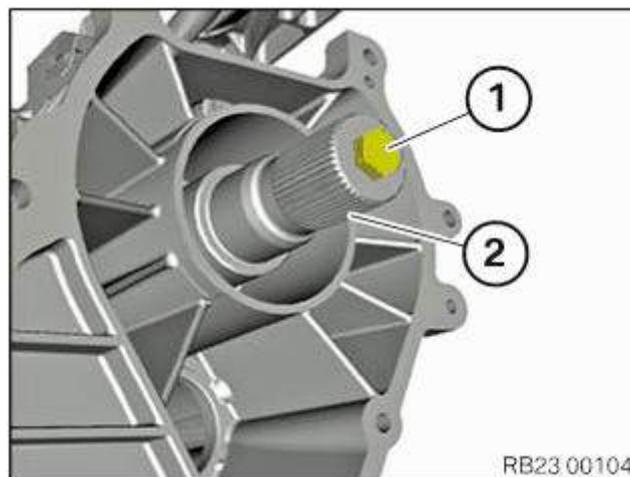
Fig. 5: Identifying Transmission Shaft And Screw

Loosen and screw out screw (1) from the adapter shaft of the transmission (2).

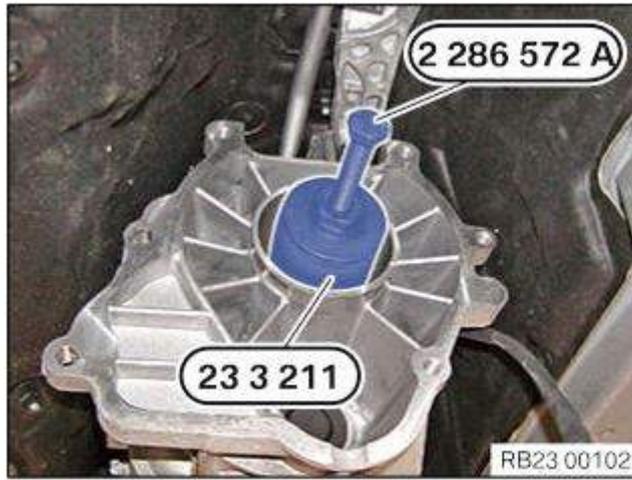
Unscrew screw [2 286 572 A](#) as far as possible out of special tool 23 3 211.

Screw special tool 23 3 211 tightly into radial shaft seal.

Fig. 8: Identifying Special Tool (23 3 211)

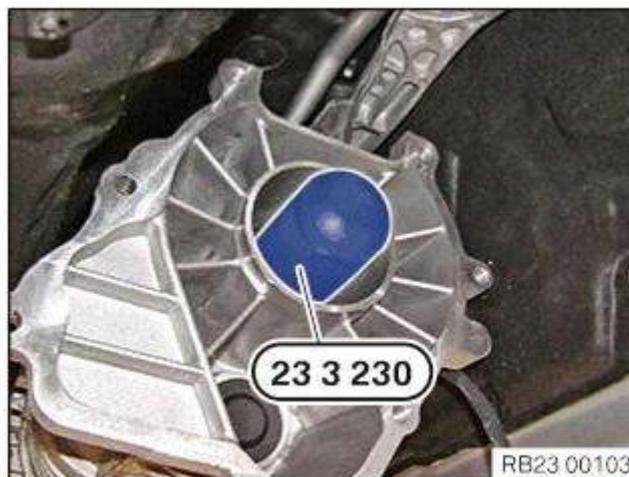
Coat sealing lips of new radial shaft seal with transmission oil.

Drive in radial shaft seal with special tool [23 3 230](#) until flush.

Fig. 9: Identifying Special Tool (23 3 230)

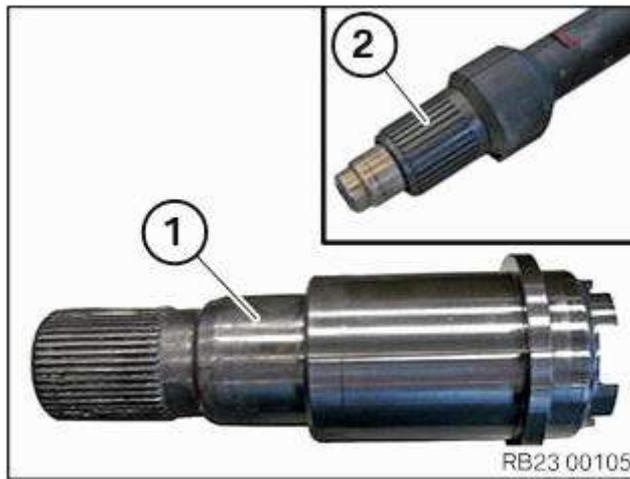
Fig. 10: Identifying Adapter Shaft Heating Area
 Courtesy of BMW OF NORTH AMERICA, INC.

NOTE: Maximum temperature of the adapter shaft: 120Â°C.
